# 微波斷層測試+ 紅外線熱像測試+表面濕度測量 濕度檢測報告一覽

## 報告總結

### 3.0 Conclusions

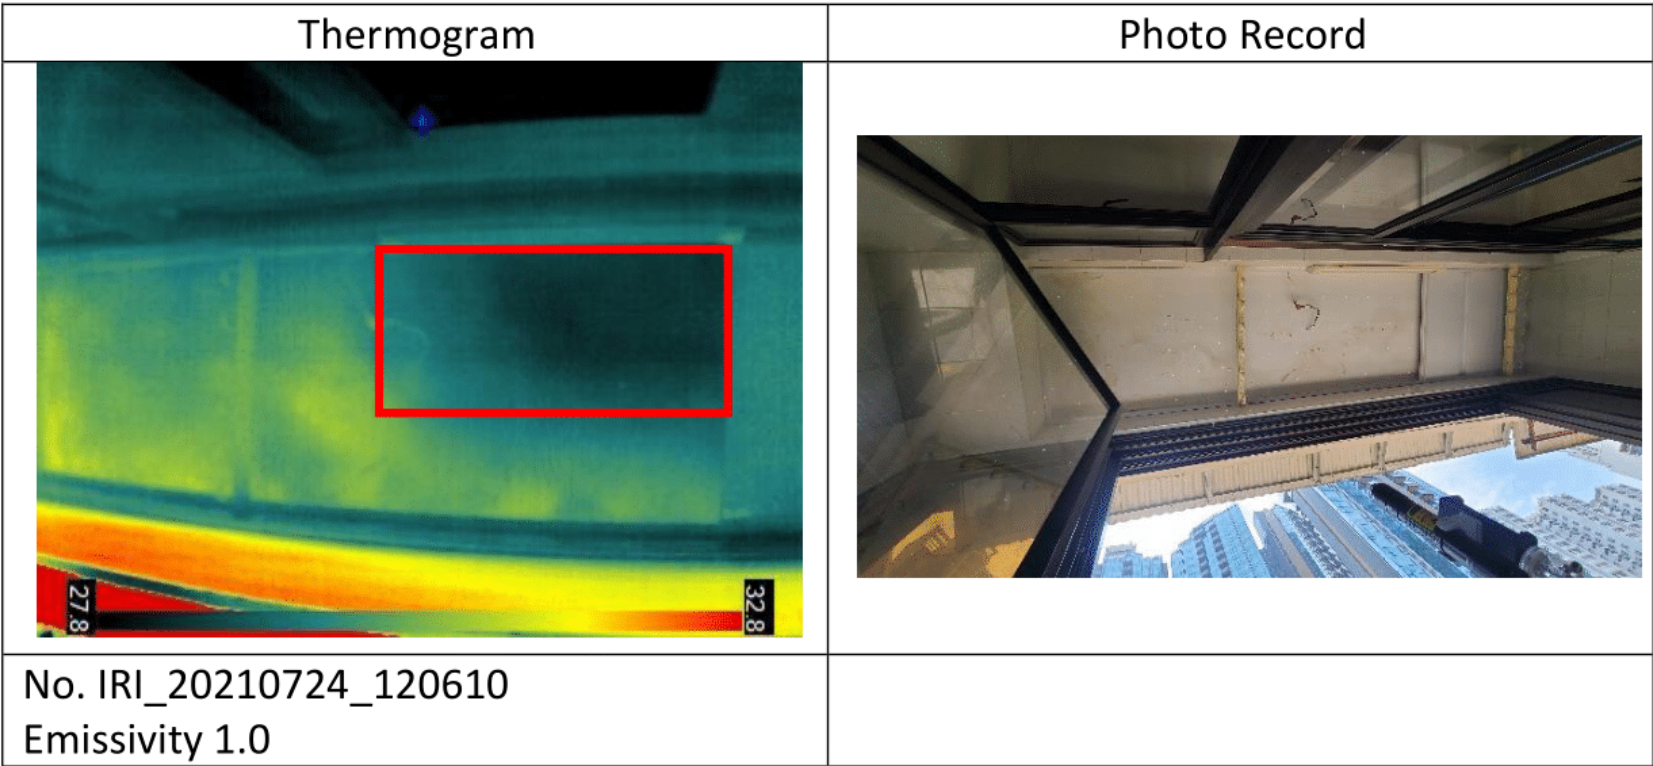
Appendix 10: Infrared Thermography Test of Location 4

- Indicated lower temperature zone

Part 2: Test summary  
Low temperature zone was observed of Location 4.

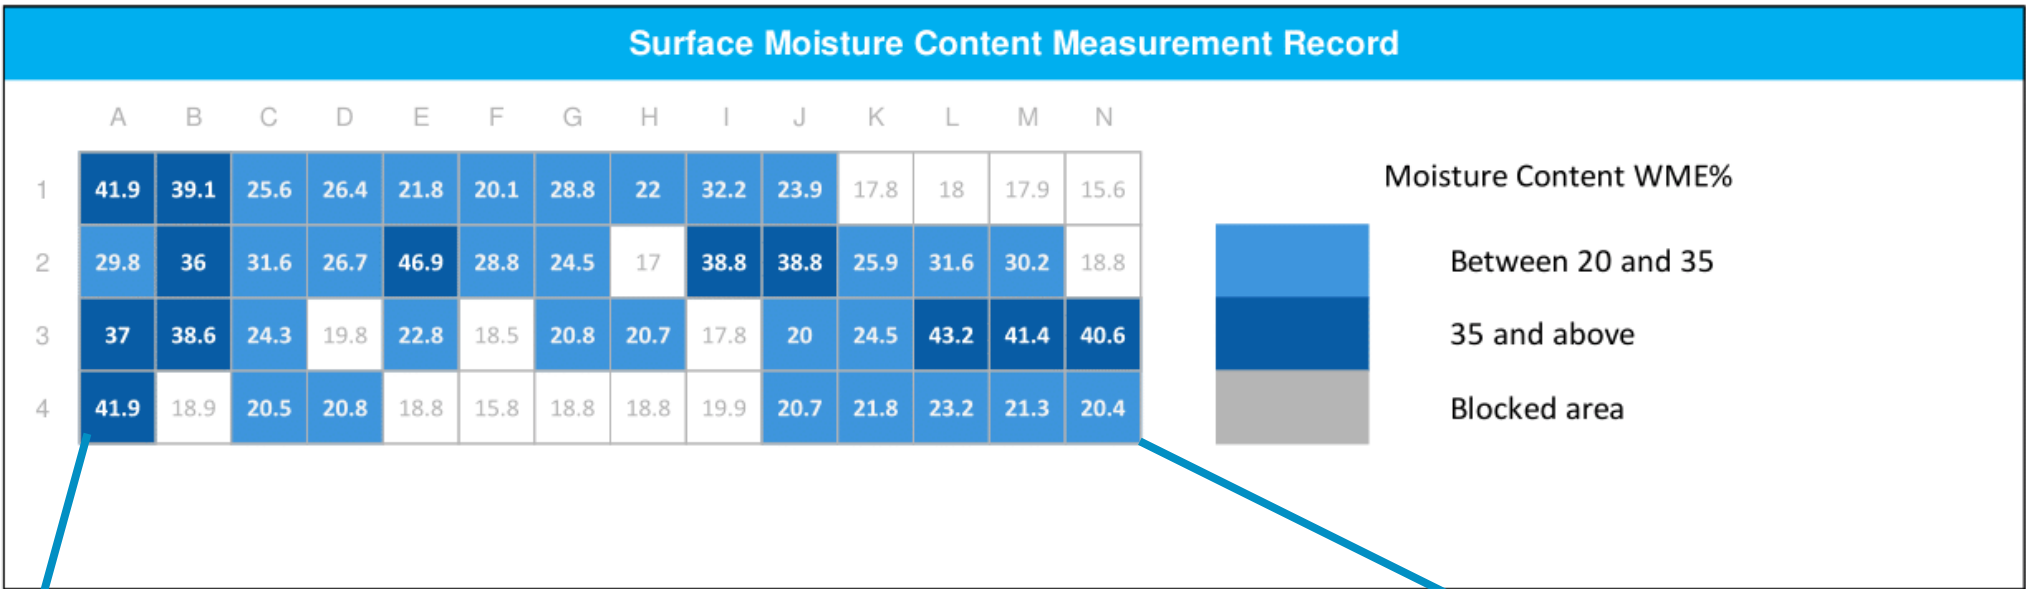
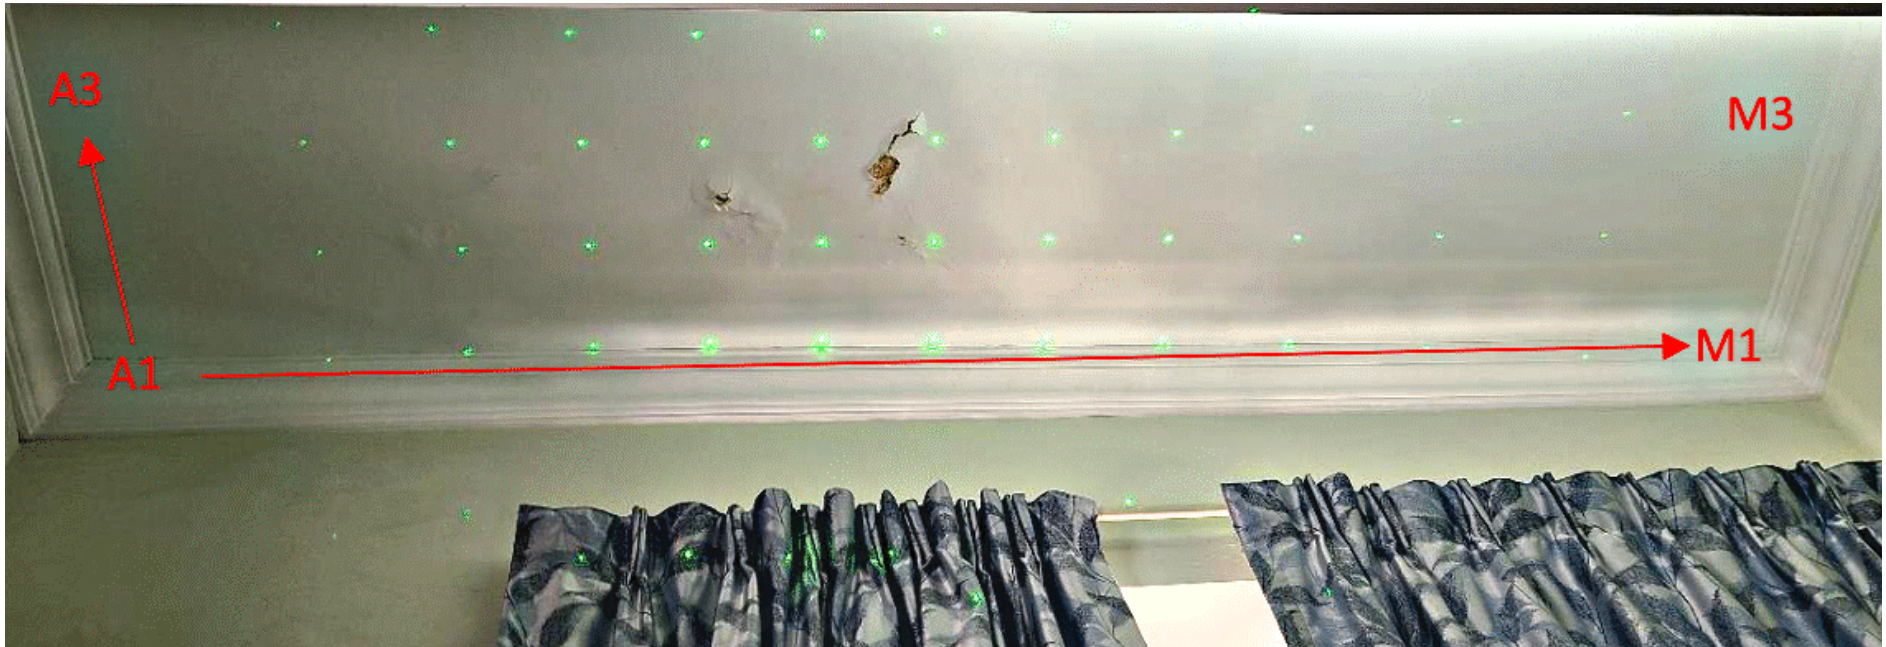
Appendix 11 Moisture Content Measurement of Location 4

Standard of dry is <= 35 WME% in accordance of the Joint Office (FEHD and BD) standard

部分甲、乙分別為之前介紹過的紅外線及表面濕度測試。  
測試範圍被分為正方形的小區塊，以分析每區塊的濕度數據  
（見右方表格）。  
淺藍格代表濕度20%-35%；  
深藍格代表 >35%

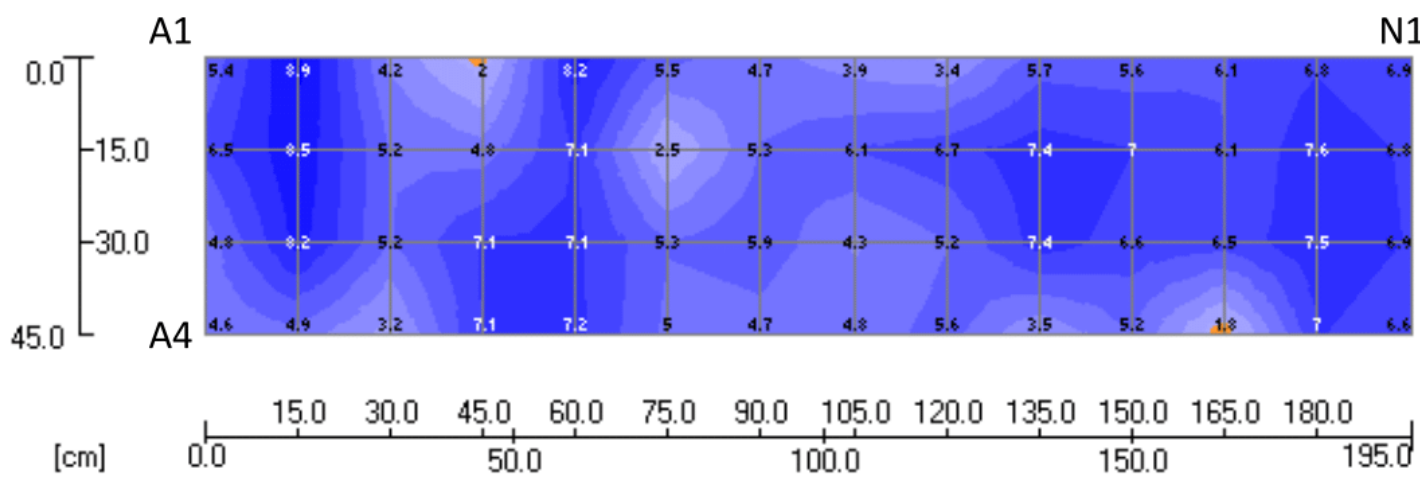
2D Plot of microwave concrete sub-layer tomography of Sensor R1-30mm

左圖表格中的藍格  
以及2D濕度分佈圖的藍色，  
均反映該區塊濕度含量高於標準。

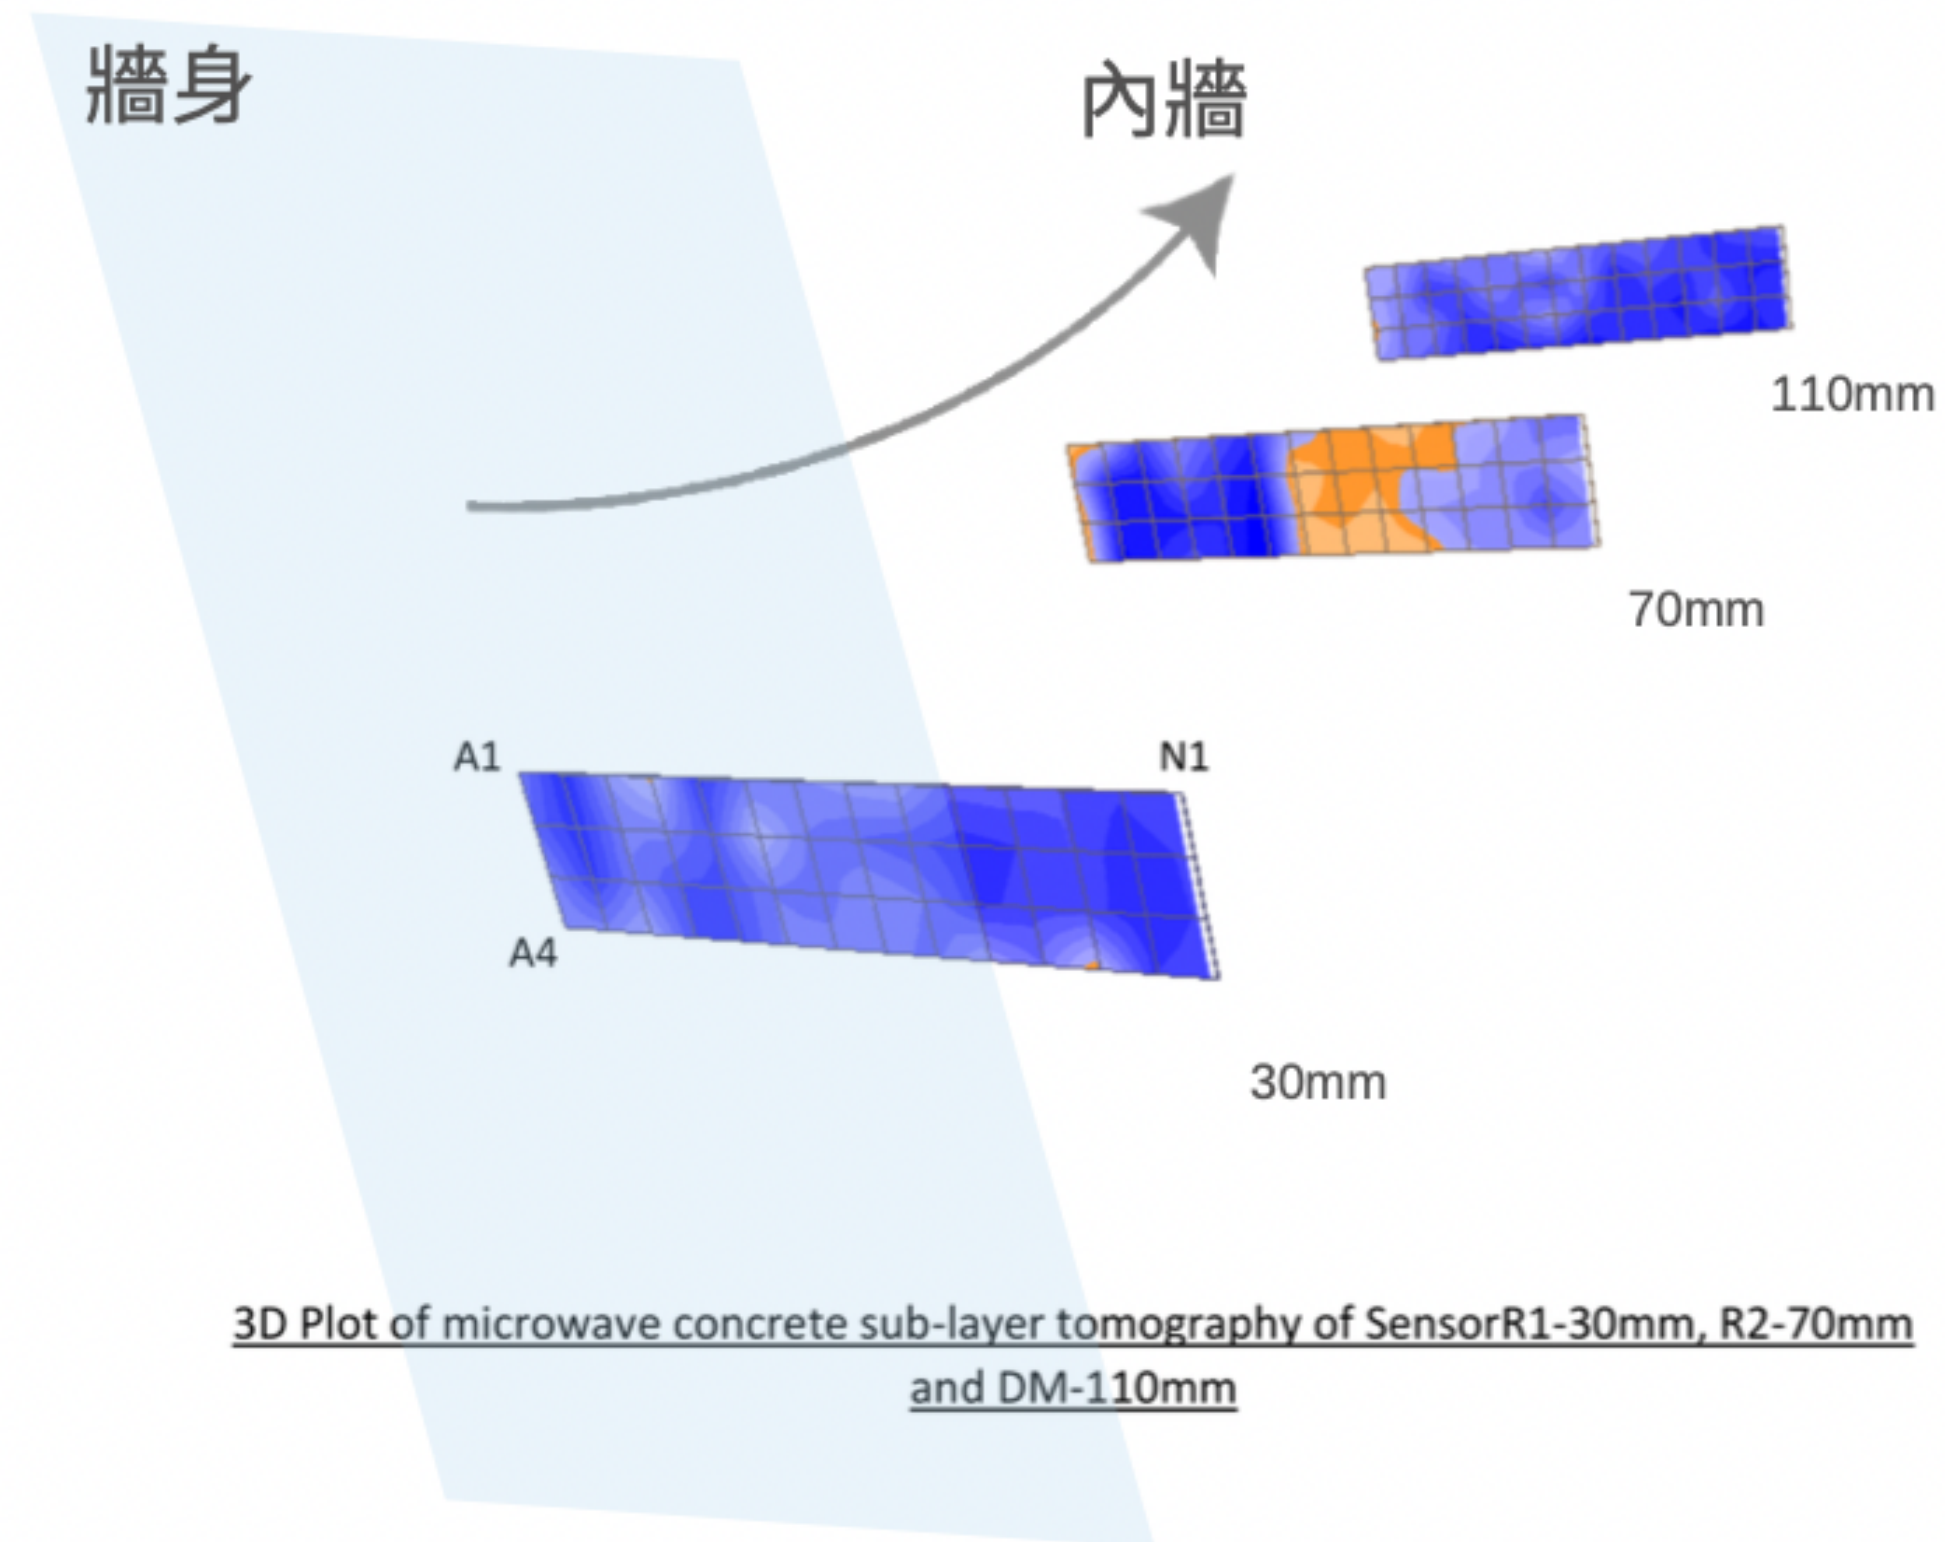
## 3D濕度分佈圖

3D濕度分佈圖能更具體地反映結構內部「斷層」出現滲漏的區域及程度，有助日後對症下藥處理問題。

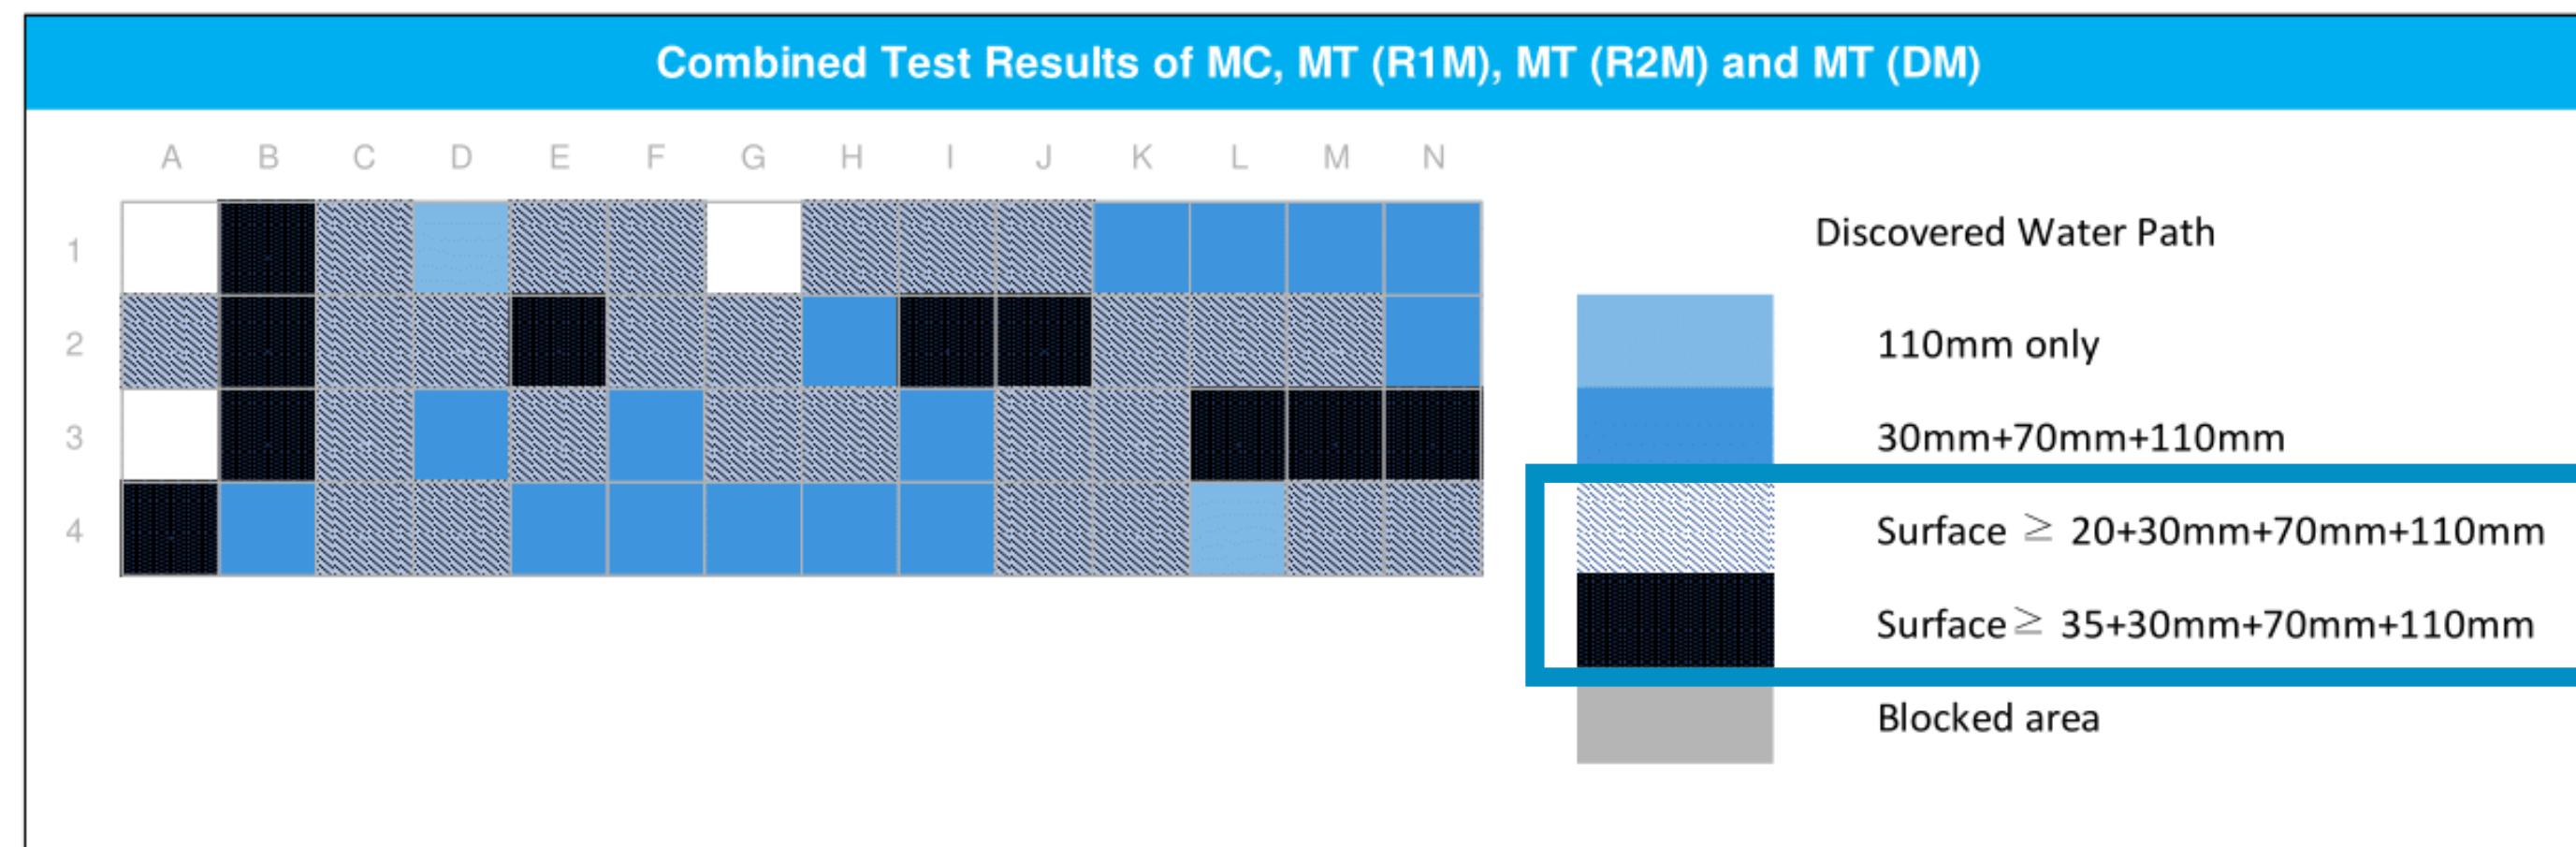
### Part 3: Test summary

濕度 >20% (國際標準)  
濕度 >35% (滲水辦標準)

*Water infiltration was observed at gridline-B and gridline-N to gridline-C and gridline-H.*

經過三款深度探頭進行微波斷層測試，  
花紋格及黑格均代表該區塊出現明顯水源。  
以B欄為例，出現連續三個黑格，代表該處滲漏問題甚為嚴重，必須儘快處理。
