# 紅外線熱像測試+表面濕度測量 濕度檢測報告一覽

## TEST REPORT

| Appendix 1 | Thermal images and site photo records | |

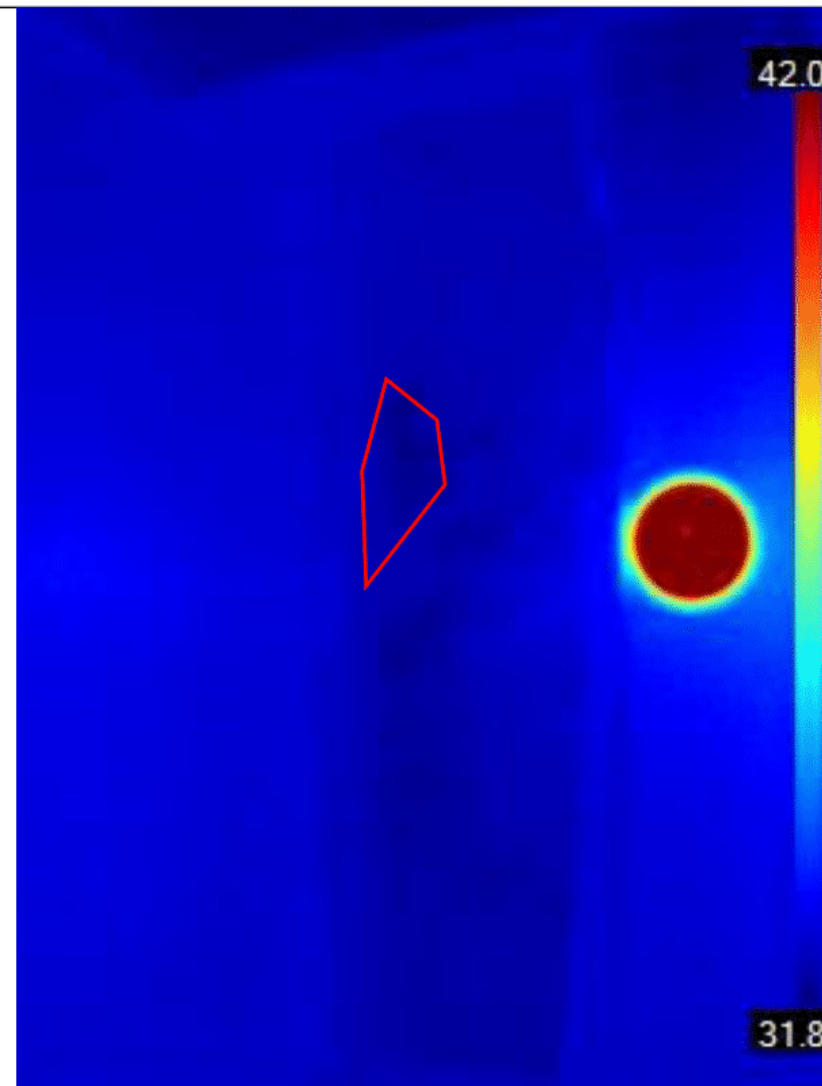
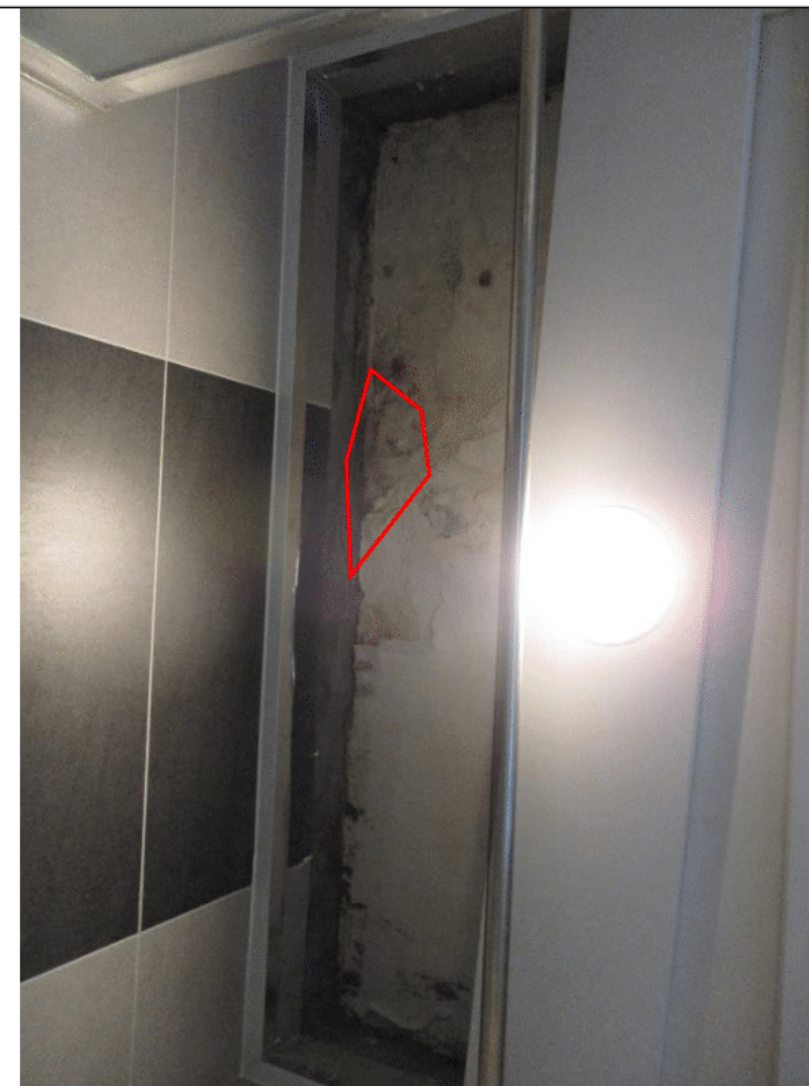
Ceiling of bathroom

| Test Result | Low energy zone was observed both to the ceiling of bath room and kitchen | |

- 紅外線熱像測試結果顯示浴室及廚房天花發現低溫區，意味該區域極有可能出現滲漏。
- 此數據是證明漏水源頭的其中一個重要證據。

Low energy zone was observed

| Professional Advises | Verification by surface moisture content measurement | |

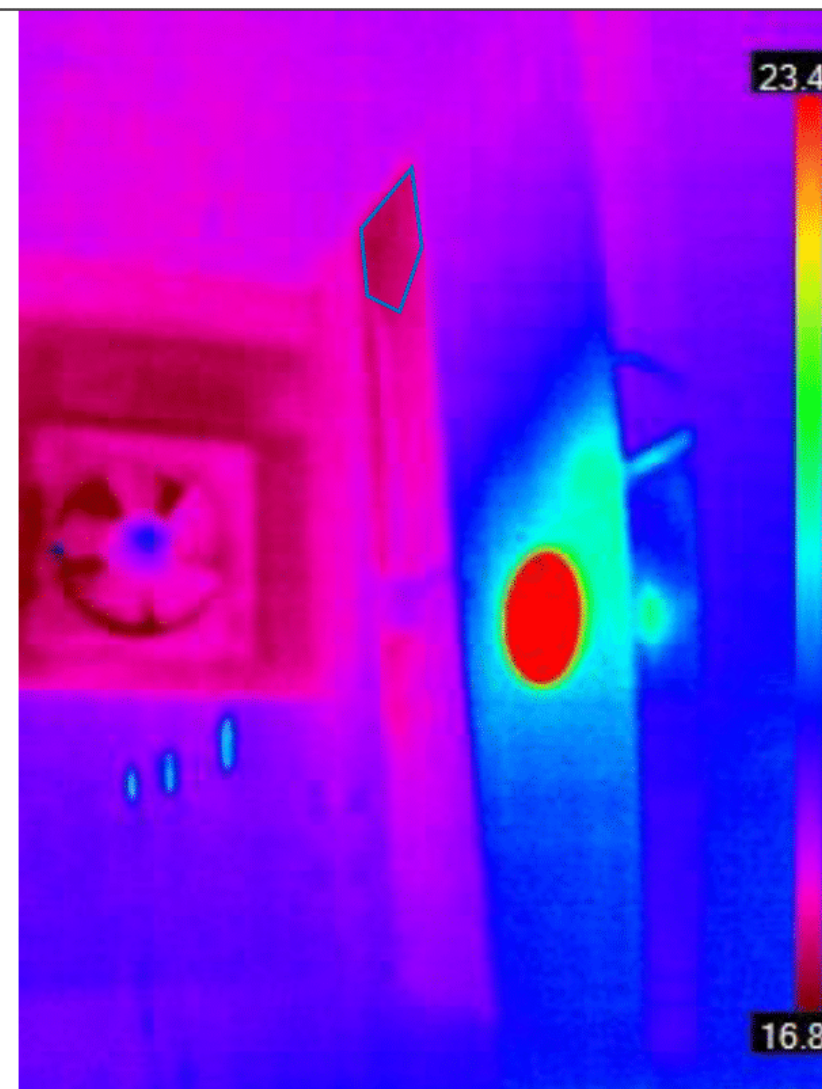
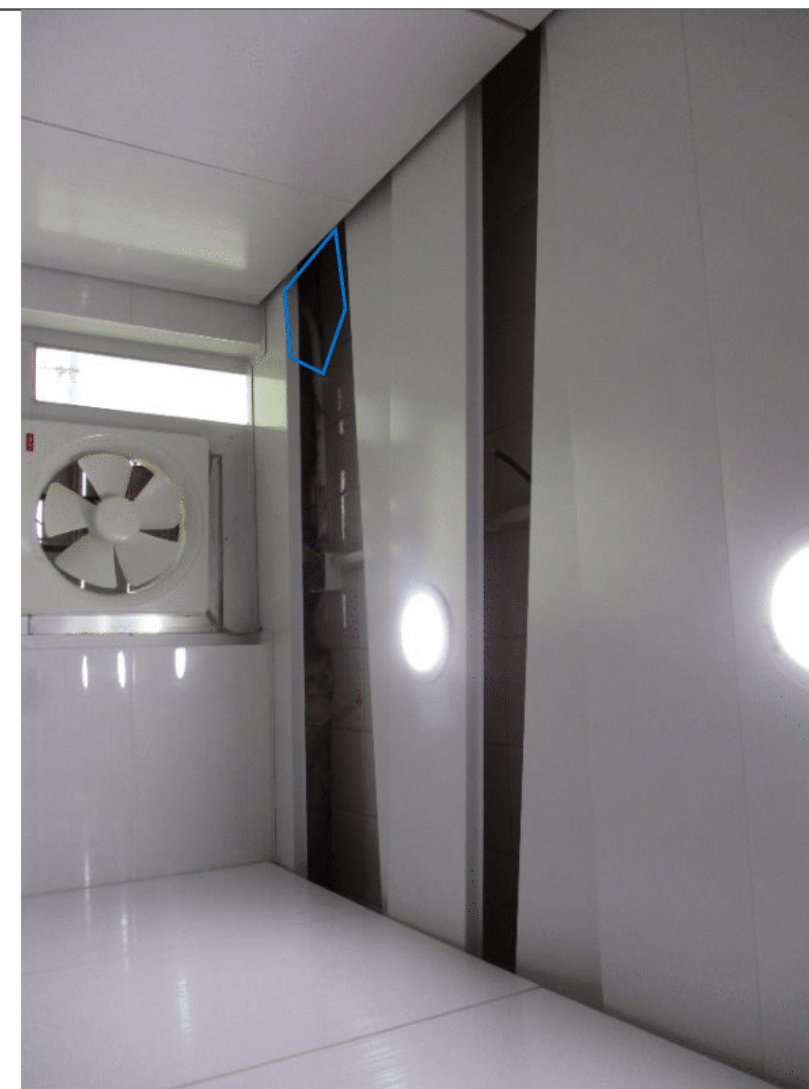
Ceiling of kitchen

Low energy zone was observed
